DIAGNOSIS AND REPAIR OF GYPSUM PLASTER COATINGS: STATISTICAL CHARACTERIZATION AND LESSONS LEARNED FROM A FIELD SURVEY

Abstract. This paper provides the statistical characterization of the pathological situation of 119 gypsum plaster coatings applied to partition walls and ceilings (inner gypsum plasters – IGP), the diagnosis methods that can be used to characterize the defects and confirm their causes, and the most suitable repair solutions. The results presented in this paper were achieved via the use of an expert system developed by the authors in an extensive inspection programme covering 23 buildings. A comprehensive set of charts and their detailed statistical analysis describe the results achieved, including the characteristics (temporal, spatial and severity) and frequency of the defects in the sample and the main causes of their occurrence in walls and ceilings. The most appropriate diagnosis methods, preventive measures and repair solutions prescribed for these defects in the sample are also analyzed and the most significant correlations presented. Even though in some instances the pathological situation of IGP is common knowledge, this time it has been characterized via

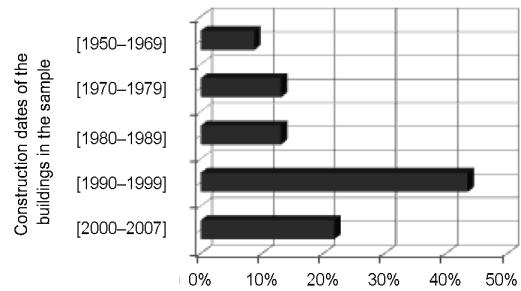
Fig. 1. Construction dates of the buildings in the sample

Figure 1 shows the distribution of construction dates of the buildings in the sample. Most date from the 1990s (43%) while 9% are from the fifties and sixties. The period of massive construction of buildings in Portugal is well represented: 65% were built after 1990. Their average age is 18 years and the oldest ones were built in 1945; thus the sample can be considered as “recent buildings”. The “pathological characterization” of the IGPs inspected includes the relationship between the average number of defects and their causes in the sample and the age of the building. Therefore, the pathologies found and the prescribed repair techniques differ considerably from those of old gypsum plasters (Silveira *et al.* 2007; Cotrim *et al.* 2008).

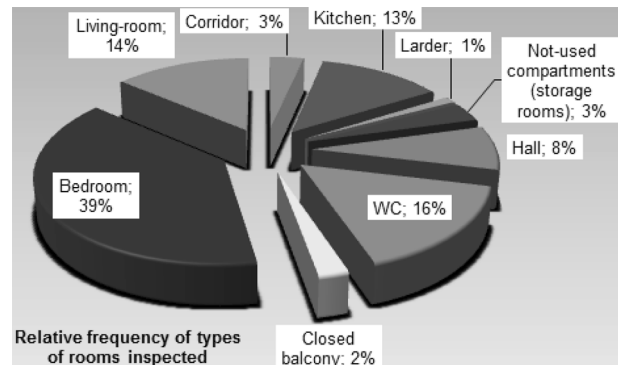
Fig. 2. Relative frequency of types of rooms inspected (Palha *et al.* 2011)

All the compartments of each apartment or office block were visited as part of the inspection. Therefore, IGPs with defects were found in kitchens, bathrooms and closed balconies (damp areas or compartments more susceptible to the action of water, which are 31% of the sample) and, more especially, in bedrooms and living rooms (39% and 14%, respectively) (Fig. 2).

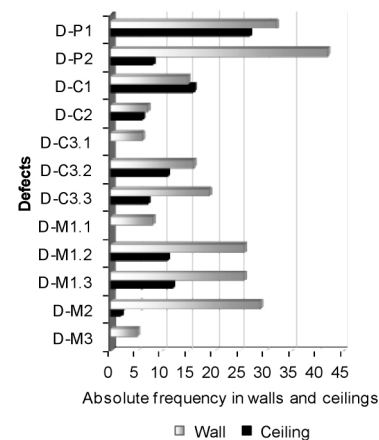
Fig. 4. Absolute frequency of defects in walls and ceilings

Figure 4 shows the absolute frequency of defects in walls and ceilings. Most defects occur with similar frequency in both kinds of surfaces, except *D-P2 – dirt*, *D-M2 – impact and other mechanical actions* and those from *D-M1 – cracking*, which occur more often in walls. The two first defects have different frequencies because the occupants have more access to the walls. Regarding group *D-M1 – cracking*, the difference is clearly related to the inability of most of the walls to support the deformation of the beams (due to dead loads) without cracking.

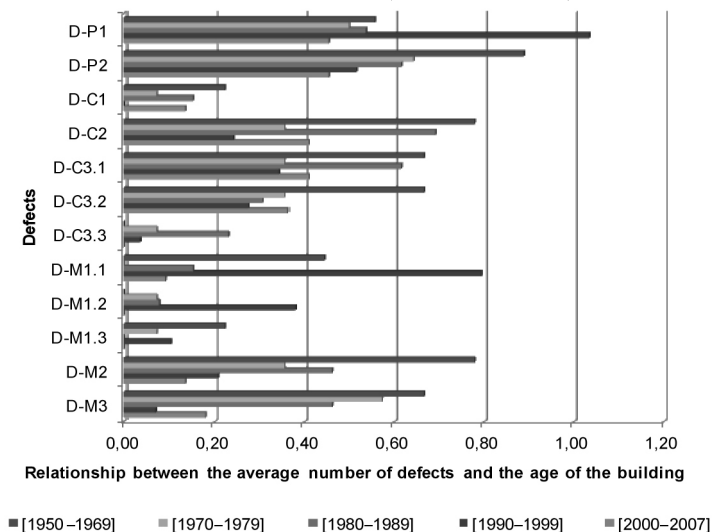
Fig. 5. Relationship between the average number of defects of each type and the age of the building

Figure 5 shows the relationship between the average number of defects of each type and the age of the building. There are not necessarily more defects in old buildings, but the average number of defects in the rooms of the buildings from the 1950–1969 period (0.49) is clearly higher than in the rooms of the buildings from the 2000–2007 period (0.22). This shows that construction methods, performance and resistance of the materials all improved, but also that natural ageing helped to increase the number of defects (Palha *et al.* 2011).

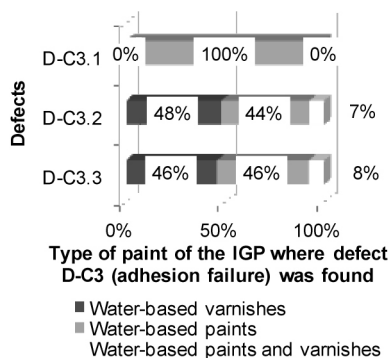
Fig. 6. Type of paint finish on IGP's where defect D-C3 (adhesion failure) was found

To corroborate these observations, Figure 6 shows the types of paint used on IGP's where defect D-C3 – adhesion failure was found. The frequency of defects D-C3.2 – warping and D-C3.3 – loosening of an area on IGP's coated with enamel or water-based varnish is always same as or higher than the frequency of these defects in IGP's coated with a water-based paint. This shows a strong correlation between these defects and the enamel or water-based varnish, even though 74% of IGP's have a water-based paint finish.

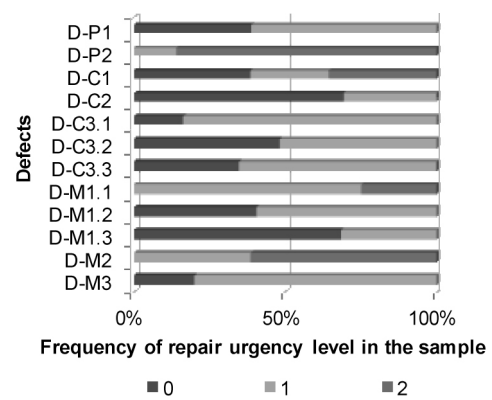
Fig. 7. Frequency of repair urgency level for each type of defect in the sample

requires it. The commonest repair urgency level is "1" (44%) and the level with lowest severity (2) represents only 23% of the sample. The conclusions are different, however, for the frequency of each repair urgency level per defect (Fig. 7). Defects D-P1 – damp, D-C1 – biodeterioration, D-C2 – efflorescence/cryptoflorescence, D-C3.2 – adhesion failure – warping, D-M1.1 – cracking – superficial/craquelé and D-M1.3 – cracking – linear and deep, have the highest repair urgency in more than 33% of the observations in the sample. This is probably related to their tendency to progress. If, when some of these defects are found, there is no intervention they will worsen and the IGP will deteriorate. Aesthetic defects, such as D-P1 – damp and D-M2 – impact and other mechanical actions, have less demanding repair urgency levels in most situations (more than 40% frequency of level 2).

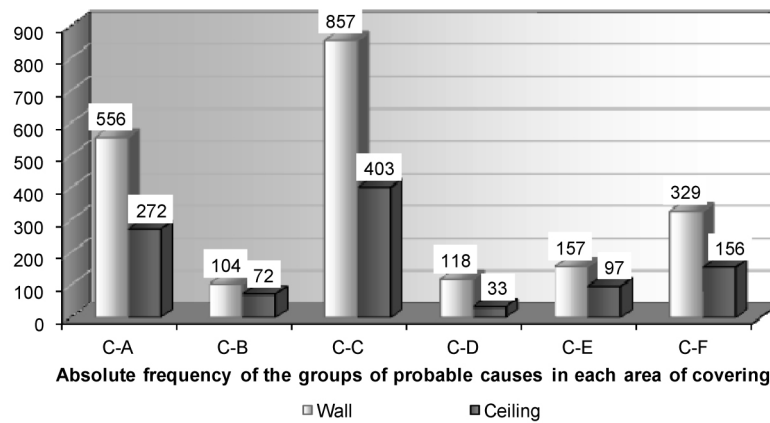
Fig. 8. Absolute frequency of the groups of probable causes in each area of coating: walls or ceilings

Figure 8 shows the absolute frequency of the groups of probable causes in each area of coating: walls or ceilings. Most of the causes were associated with defects in walls, which was expected since there were more walls in the sample (231, compared with only 100 ceilings). The relationship between the number of causes in walls and ceilings is linked to the significance of these two types of coatings in the sample. Only groups of causes *C-B* – *Problems with materials* and *C-D* – *Exterior mechanical actions* do deviate from this relationship. The first group only occurs 40% more often in walls than in ceilings and the second group occurs almost four times more in walls. The first situation is hard to explain, but the second is due to the greater exposure of walls to exterior mechanical actions and to stresses transmitted by the substrate.

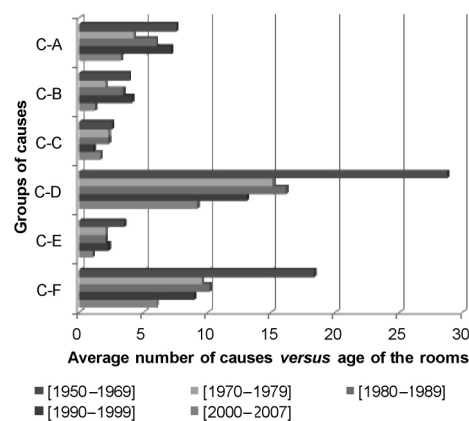
Fig. 9. Average number of causes versus age of the rooms

The distribution of the average number of causes in terms of age of the room (Fig. 9) shows a fall from the older (1950–1969 with 7.2) to the recent ones (2000–2007 with approximately 2.5). This is directly related to the considerable drop in the average number of defects between these two periods (Fig. 5).

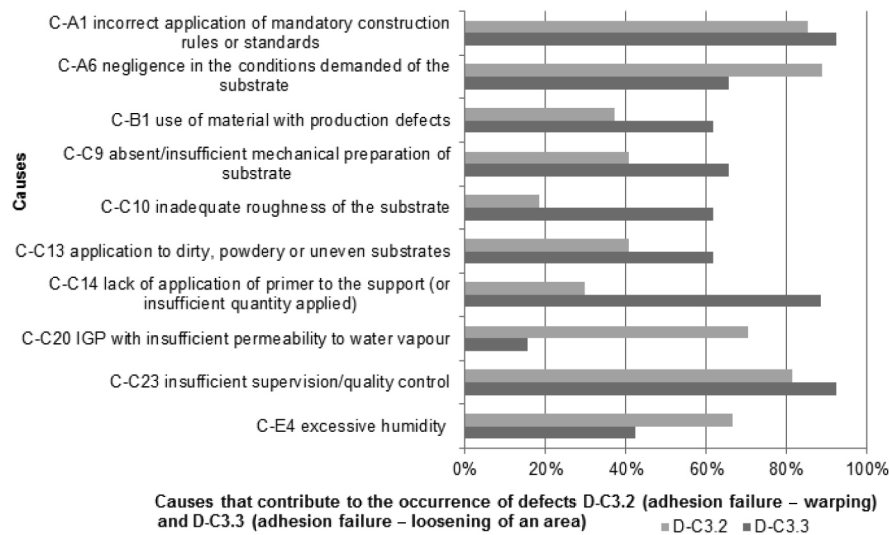
Fig. 10. Causes that contribute to the occurrence of defects D-C3.2 (adhesion failure – warping) and D-C3.3 (adhesion failure – loosening of an area)

The main causes of the occurrence of defects *D-C3.2* – *adhesion failure – warping* and *D-C3.3* – *adhesion failure – loosening of an area* – are presented together (Fig. 10) because they are all related to the loss of adhesion between coating and substrate. These defects have an average of 14 and 13.4 causes per occurrence, respectively. Most causes of these defects (*C-A6* – *negligence in the conditions demanded of the substrate*, *C-C9* – *absent/insufficient mechanical preparation of substrate* and *C-C14* – *lack of application of primer to the support (or insufficient quantity applied)*) are related to the application of IGPs to substrates when the conditions to guarantee good adhesion are not in place or when the substrates have not been mechanically prepared for the possible transmission of excess stresses by the structure or from the exterior.

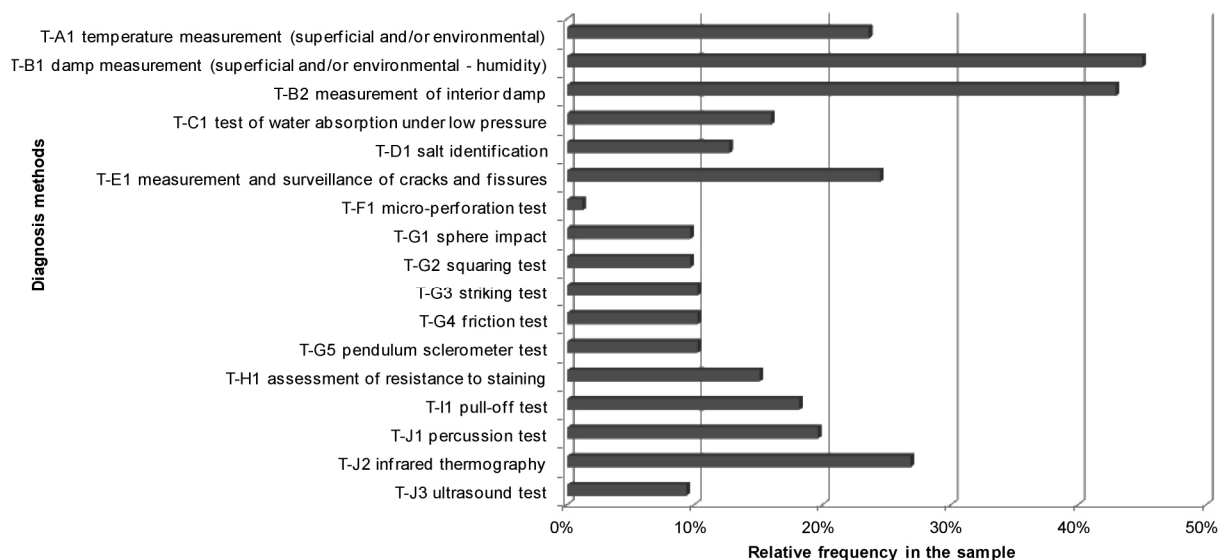
Fig. 12. Relative frequency of the diagnosis methods

The relative frequency of the diagnosis methods is presented in Figure 12. The most important ones are T-B1 (damp measurement (surface and/or environmental – humidity)) and T-B2 (measurement of interior damp) with an incidence of more than 40%. Method T-J2 (infrared thermography), despite occurring less often, is the third method most associated with defects (27%). The high frequency of these three methods is due to the great importance of defect D-P1 (damp) in the sample.

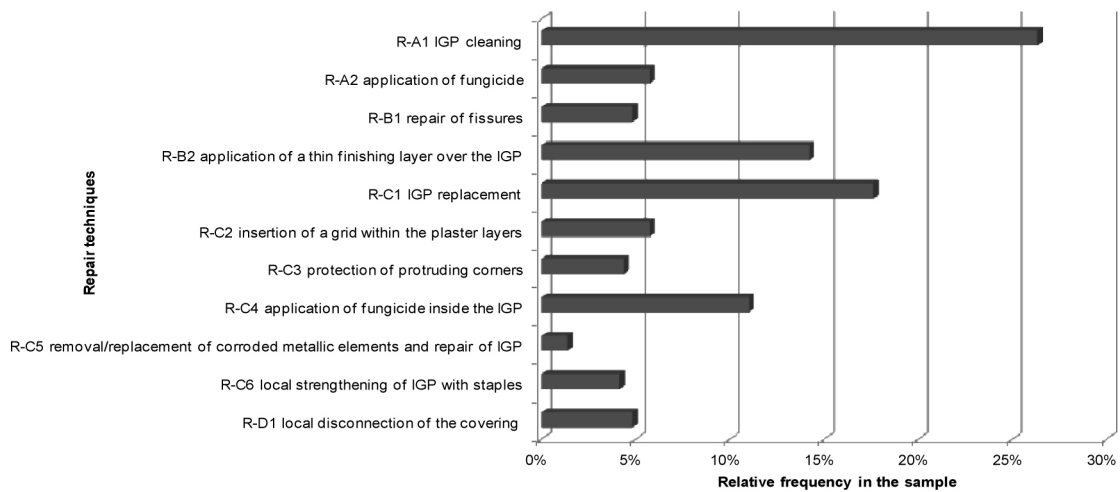
Fig. 13. Relative frequency of the repair techniques in the sample

Figure 13 shows the relative frequency of the repair techniques in the sample. *R-A1 – IGP cleaning* – was selected for 26% of the defects because it could correct most of the physical defects that are significant in the sample. But the defects were not mainly superficial, as proved by the frequency of technique *R-C1 – IGP replacement* (18%), which is reflected for all the IGPs. In fact, if all the techniques suitable for the surface (R-A) and finishing layer (R-B) of the IGP are compared with all the methods applicable to the entire IGP (R-C) and to its interface with the substrate (R-D), the difference is slight (51% *versus* 49%), which shows a balance of the defects in terms of depth.

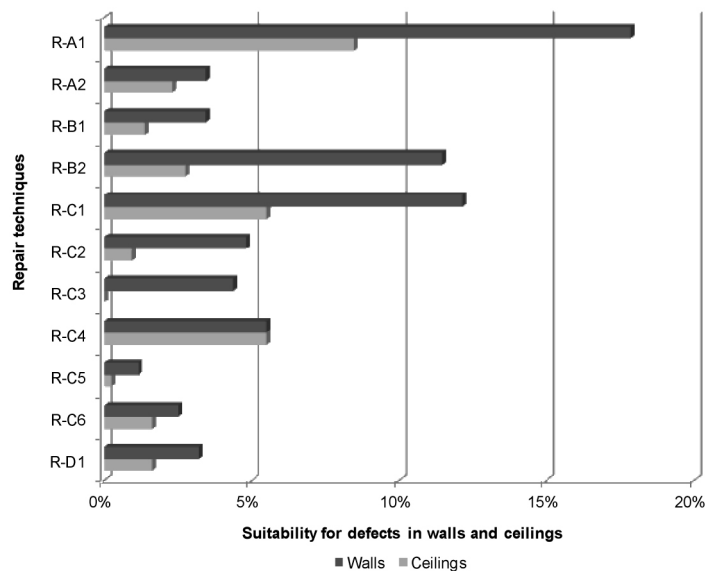
Fig. 14. Suitability of each repair technique for defects in walls and ceilings

Figure 14 indicates the suitability of each repair technique for defects in walls and ceilings. All techniques were prescribed for walls and ceilings alike, apart from these five: R-A1 – IGP cleaning; R-B2 – application of a thin finishing layer over the IGP; R-C1 – IGP replacement; R-C2 – insertion of a grid within the plaster layers, and R-C3 – protection of protruding corners. Technique R-B2 was used more often for walls because in 37% of the cases it was associated with defect D-M2 (impact and other mechanical actions), which occurs on walls 94% of the time (Fig. 4). Technique R-C2 is more suitable for walls because it is best for defect D-M1.3 (cracking – linear and deep), which occurs in walls in 70% of cases.

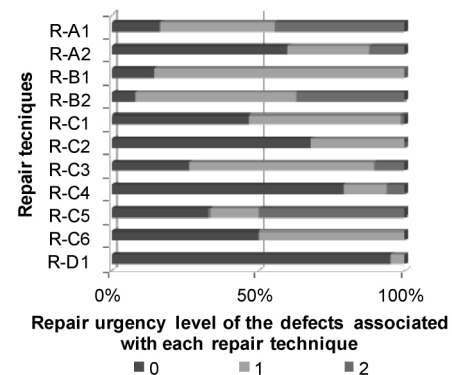
Fig. 15. Repair urgency level of the defects associated with each repair technique

The repair urgency level was defined for each defect, generally based on its extent (area affected) and stability. Stability is also very important for the choice of the most suitable repair technique. The repair urgency level is therefore not related to the depth of the defect repaired. Figure 15 presents the repair urgency level of the defects associated with each repair technique.

Techniques related to the IGP surface (R-A) and the finishing layer (R-B) are associated with lower defect severity levels (1 and 2). The opposite is observed with more intrusive techniques (R-C and R-D): more than 50% of the prescriptions for repair techniques R-C2 (insertion of a grid within the plaster layers), R-C6 (local strengthening of IGP with staples) and R-D1 (local disconnection of the coating) were made for defects with a higher repair urgency level (0). But methods R-A2 (application of fungicide) and R-C5 (removal/replacement of corroded metal elements and repair of IGP) are not in line with this assignment of the repair techniques by defect severity level. Technique R-A2 is a superficial intervention associated with 60% of defects with severity level 0 because it is only used when the corresponding defect (D-C1 – biodeterioration) is not stabilized. Technique R-C5 is almost independent of the severity level of the IGP defects, and is directly related to the condition of the metal elements, which gives it one of the most homogeneous distributions of repair urgency levels.

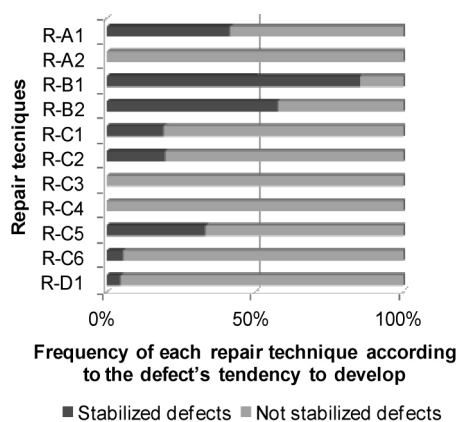
Fig. 16. Frequency of each repair technique according to the defect's tendency to develop

Figure 16 shows the frequency of each repair technique according to the development of the corresponding defects. Technique R-A1 (IGP cleaning) does not improve the IGP characteristics, but it was associated with the majority of the stabilized defects, which seems contradictory. This may be related to the simplicity and economy of using this technique on a periodic basis, thereby making it almost a maintenance task. This repair technique can also be used to check the stabilization of defects: dirt/damp is removed and the reappearance of the defects is checked, which can justify a more serious intervention. Nor does method R-C1 (IGP replacement) improve the IGP, but it was associated with 81% of the defects not stabilized. This can be explained by the lack of techniques to prevent the reappearance of some defects when the cause of the pathological defect is not eliminated. Among these defects are: D-C3 (adhesion failure),
